PILOT CONSERVATION PROJECT STRATEGY DEVELOPMENT REPORT

**Presqu'ile Point Lighthouse
Brighton, Ontario**

**Prepared for: Presqu'ile Point Lighthouse Preservation Society
June 2016**

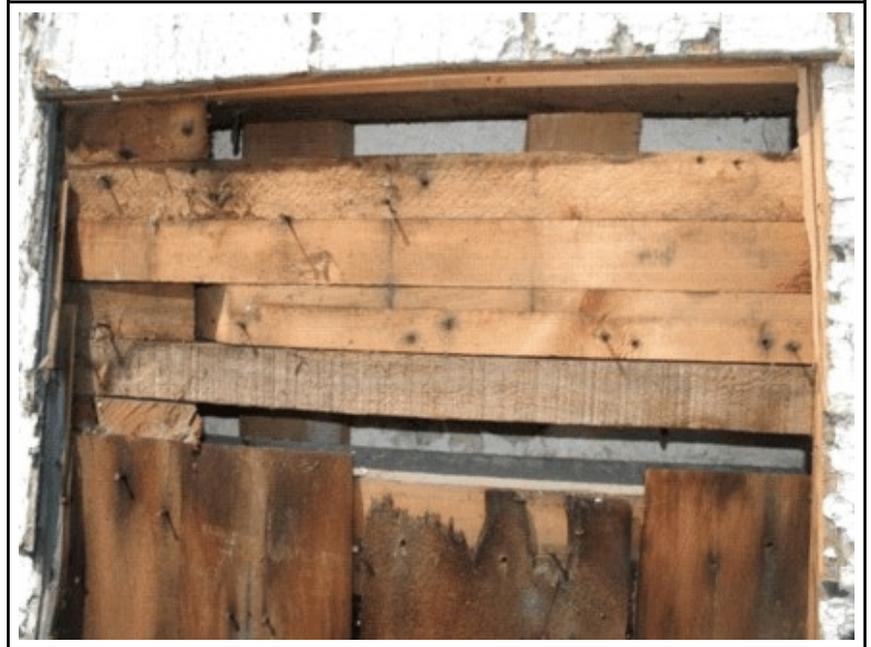
.1 It is reported that the shingled cladding was applied over 2-in x 4-in (50-mm x 100-mm) horizontal girts. However, an image extracted from a 2014 investigation report by the consultant team Scheinman and Silburn indicates that varying conditions are likely to exist beneath the shingles. [See Photograph 1.]

Photo. 1: An image extracted from a 2014 investigation report by Scheinman and Silburn which illustrates varying conditions within an area where shingles were removed to reveal underlying woodwork.

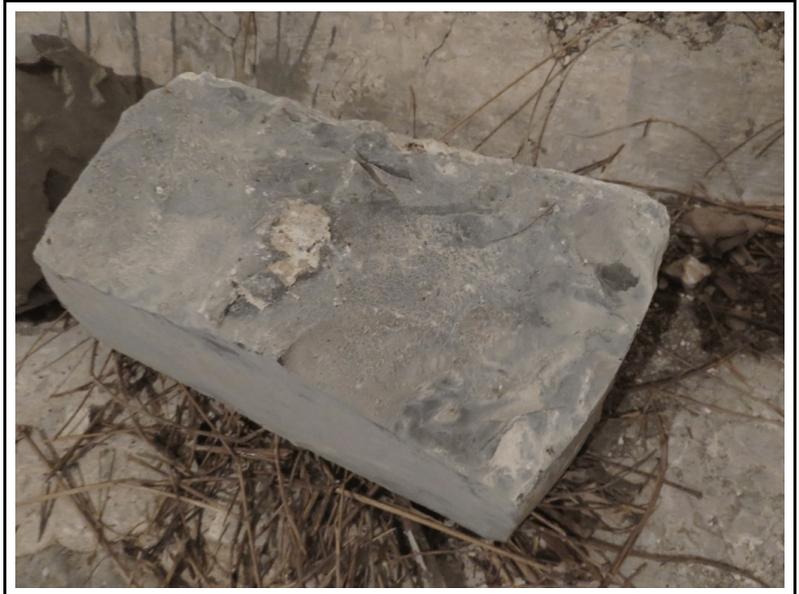
- .7 Various report authors have commented that the dimension stone used for the lighthouse masonry was an inferior local shore stone. However, the Consultants have yet to see evidence of poor quality; although the stone units observed within the interior appeared to be fabricated from a very tough, dense, fine-grained but brittle, limestone that - if face-bedded - could have the propensity to crack under an “over-loaded” condition. [See Photograph 2.]

Photo 2: This stone unit, which was apparently removed from the interior masonry, appears to be a very dense, tough but brittle limestone.

In view of this, it seems more likely to the Consultants that the initial deterioration was primarily caused by the use of inferior, on-site produced bedding and pointing mortars.

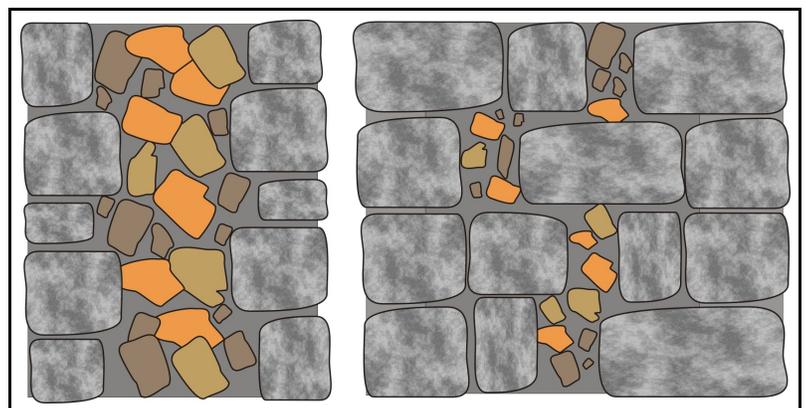
- .9 It should also be noted that it is highly unlikely there is an outer and inner wythe with a distinct central core that is comparable to most traditional mass masonry walls constructed using natural stone. In fact, human nature and the likely construction economies at that time would tend to indicate that - unlike for thinner walls (18-in to 24-in/450 to 600-mm thick range) - small off-cuts of stone and rubble pieces would most likely not

Figures 2 and 3: Not-to-scale schematic illustration of a typical vertical section through a traditional mass masonry wall (left) and the likely make-up of the lighthouse masonry assembly (right).

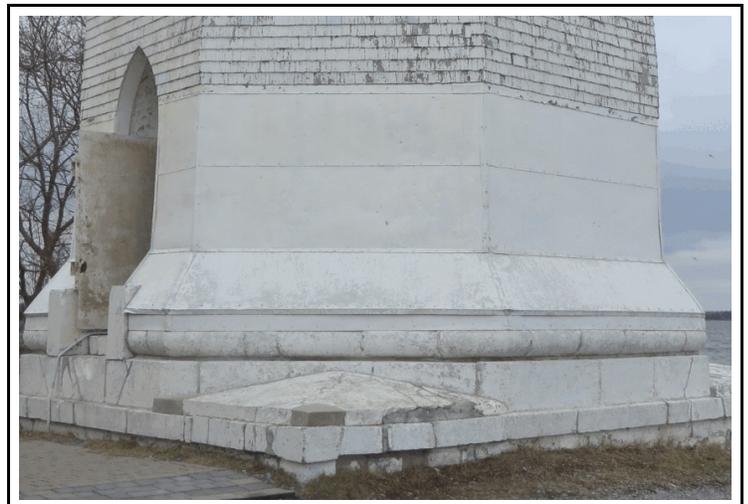
- .11 The most recent report has hypothesised that metal cladding at the base of the tower was probably installed during the 1980s to replace badly damaged shingles with a more durable material. [See Photograph 3.]

- .12 Except for some observed loose stones, the foundations were considered by the most recent study to be "impressive" and "amazingly intact". [See Photograph 3] This tends to justify the Consultants'

Photo. 3: Illustration of the metal cladding at the base of the tower above the stone foundations.

belief, expressed earlier, that past problems have most likely been linked to poor mortar, rather than the quality of the stone. However, concerns have been expressed within the most recent report regarding the concrete "capping" of the corner "shoulders" which are in a poor condition.
