**PRESQU'ILE POINT LIGHTHOUSE (PPL):**  
**RESTORATION ENGINEERING STUDY**

**Prepared by:**

**November 14, 2014.**

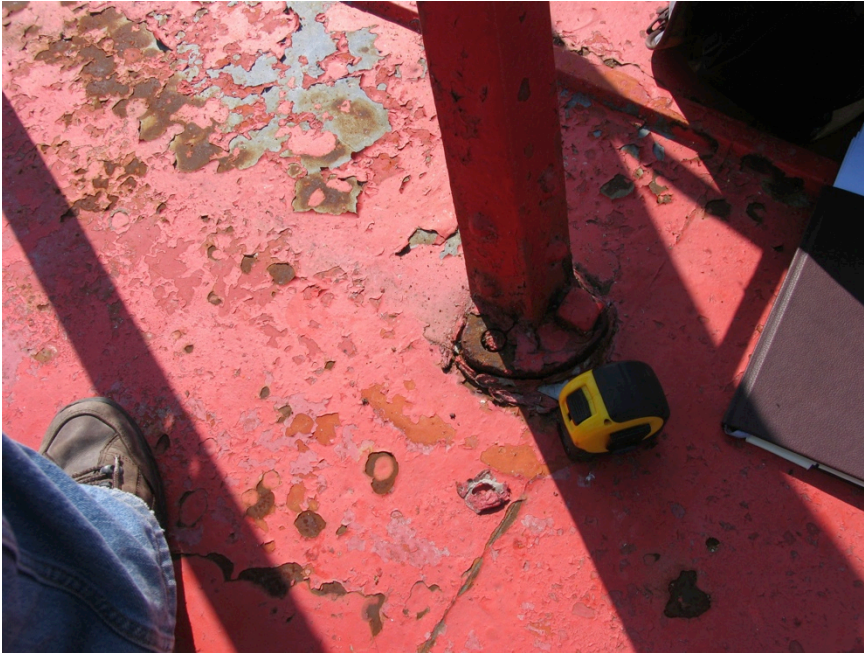
*Fig.4*

The existing roofing is a low slope batten seam treatment in galvanized metal with the 1 ¼" wide battens typically set at 29" o.c. It is assumed that the seams are soldered with the battens allowing for some measure of movement. The treatment at the roof edge is unusual as the drip edge piece appears to have been applied over the roofing putting that seam in the path of water flow (Fig. 4-5).

Paint is flaking over much of the surface and has been completely lost over approx. 25% of the surface area much of which is now corroding, particularly adjacent to the battens. Holes were noted in the metal which have the appearance of being caused by the attempt to remove ice with a pick or axe. Several occur at the metal 'fascia'. (Fig. **IMG 0116**) The area around the pipe-type guard rail's steel base plates, which seem to be simply bolted through the roofing and caulked around the perimeter are a typical problem area. Several bolts are missing and the caulking is basically coming away from around the plate edges making the assembly vulnerable to leakage.

The amalgam of potential leakage points noted above constitutes a major moisture entry problem.

Metal roofing replacement : \$24000.00

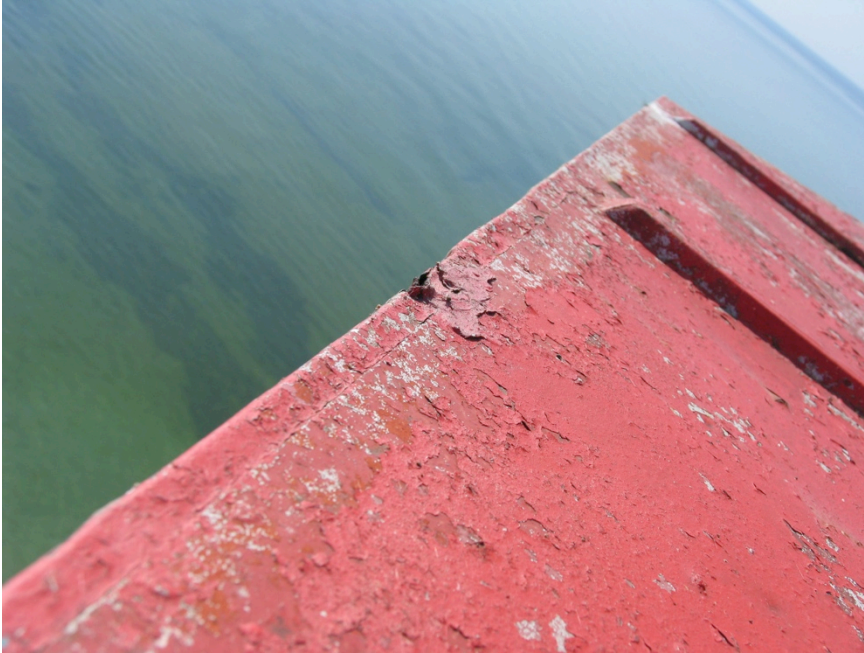
*Fig.5: Note hole at edge*

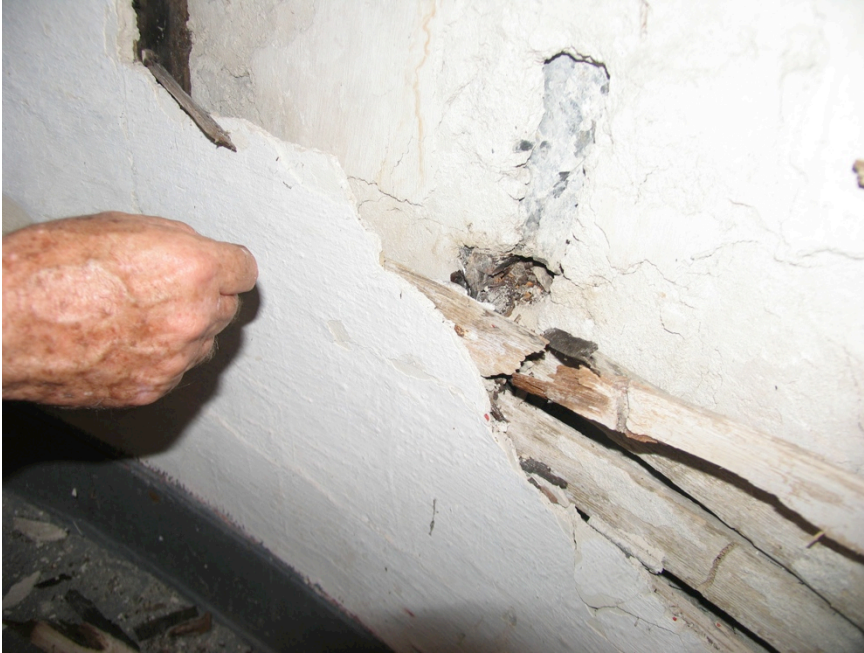
*Fig.6*

This later plaster is missing at a number of locations and the exposed lath and furring were found to be decayed in places and lathing nails corroding. On the day of this visit (August 7, 2014) these wood elements were quite damp presumably due to the leakage noted above and/or condensation occurring at the cool stone surface. It appeared that moisture was particularly high in the space between the inner and outer plaster surfaces. (Fig.6)

Plaster Conservation/Finishing \$35000.00  
(includes repair of missing, damaged and/or cracked areas; removal of recent graffiti; conservation of historic graffiti; finishing)

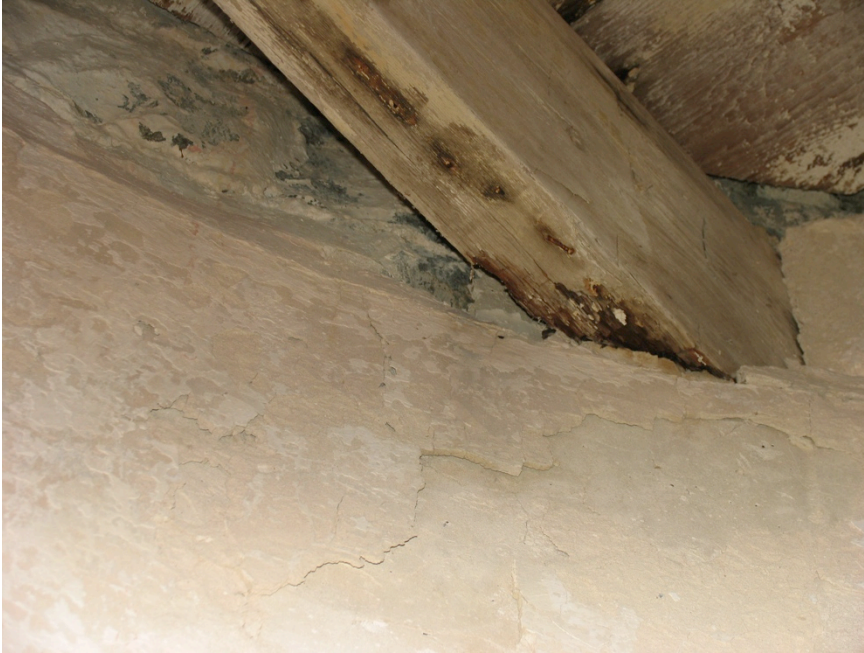
Bearing directly on and into the stone makes the joist ends vulnerable to decay. There is obvious deterioration of the joist ends at several members at the second and third floors but, given the nature of the detail and likely extent of condensation at the stone walling, there also has to be an assumption of decay at other concealed locations.

*Fig.7: Note decay extending from bearing point at wall. Also lathing? nails*

Replacement of decayed floor structure: \$12000.00

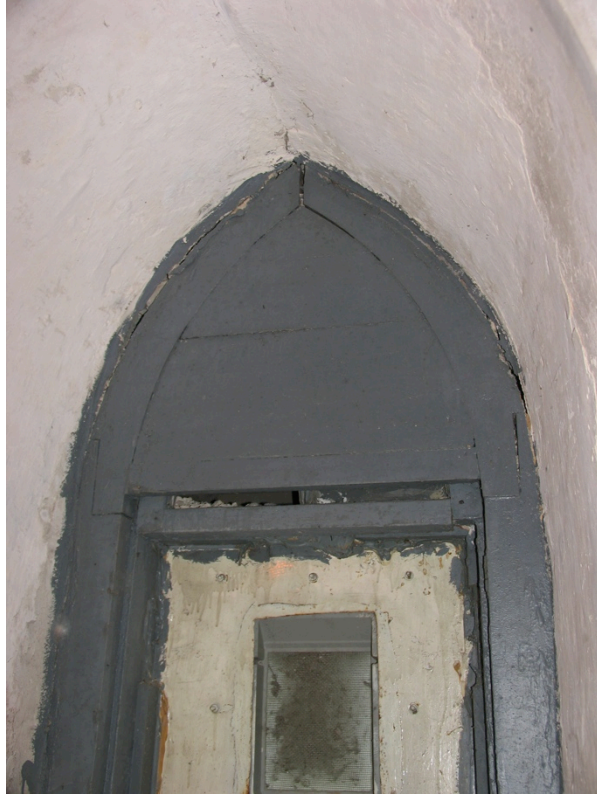
*Fig.8: Interior treatment at west elevation. Note surviving upper sash.*

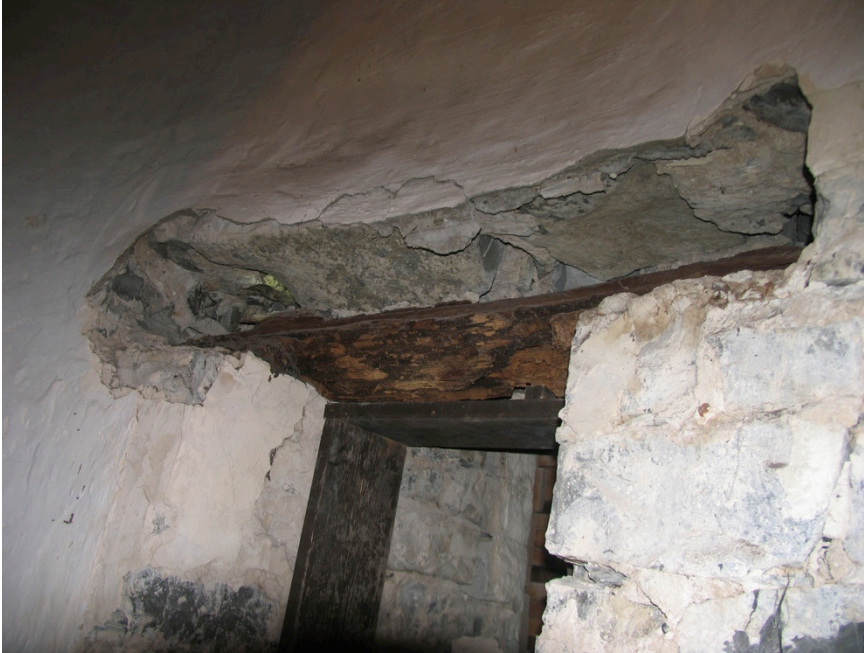
Unfortunately the timbers inserted as lintels directly into the masonry within such a high moisture environment have seriously decayed and been infested with carpenter ants.

*Fig.9: Decayed timber lintel at lowered openings - 2<sup>nd</sup> floor*

Replacement of rotted timber lintels: \$10000.00

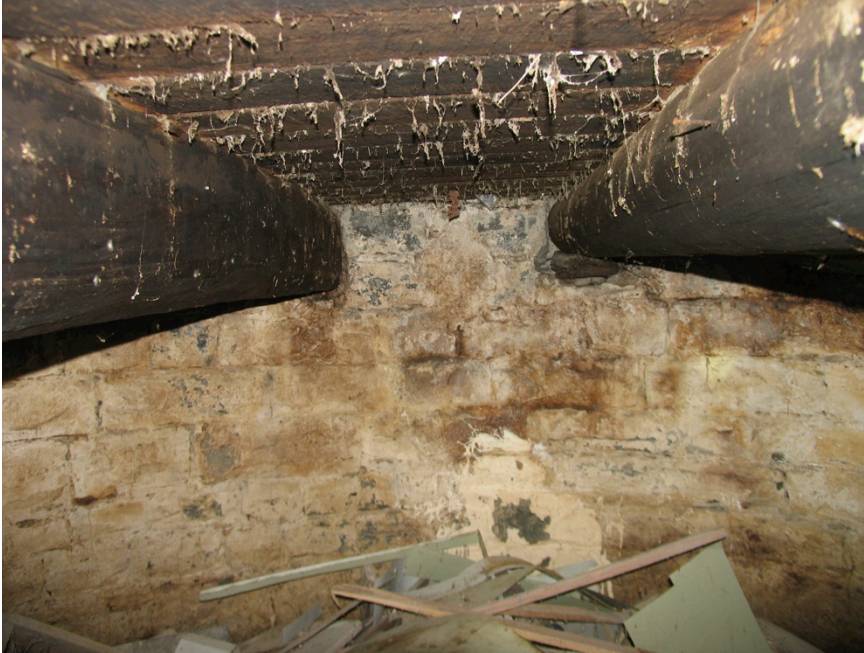
The floors structure is of heavy timber beams ranging from fully squared timber to a few members which remain three quarter round. While some members have been hewn others have been reciprocally sawn. As elsewhere they extend directly into the stonework. At some point they have been treated with creosote which accounts for the extreme odour when the hatch access hatch is opened. Despite the application of that strong preservative several of the members do exhibit decay though less than might have been expected.

*Fig.10: Note creosoted ¾ round timbers and quality of stone coursing*

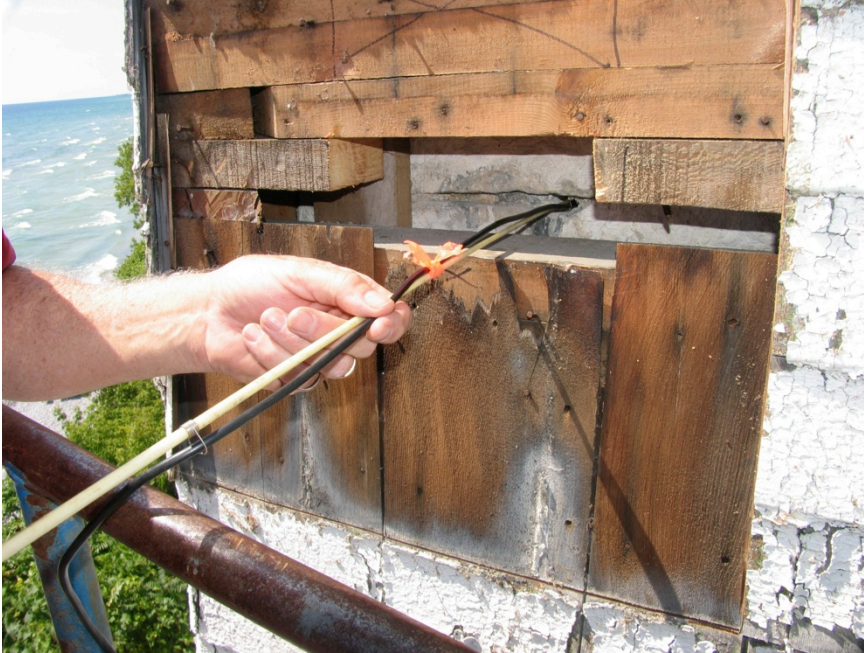
*Fig.11: Borescope probing at revealed mortar joint. Quoin masonry appears regular.*

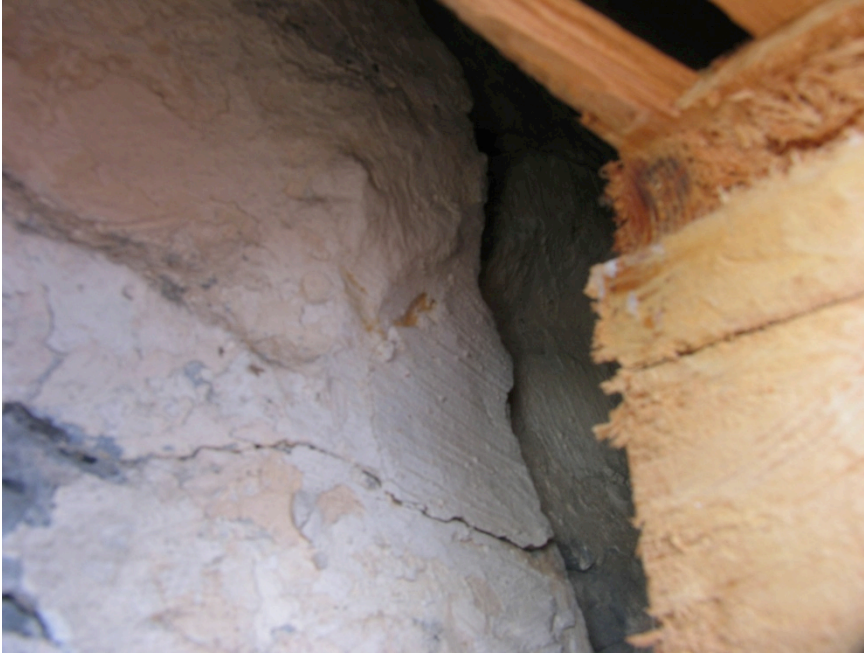
In summary the results of the investigation, though limited, appear to confirm a scenario in which a dangerous level of discontinuity existed, approximately in line with the windows, over much of the wall height across each, or at least several, elevations particularly as orientated to the prevailing wind direction. This major failure, coupled with other cracks, bulges etc. was obviously of a level of significance, that the late 19<sup>th</sup> century engineers/experts considered it unstable and requiring the extensive stabilization treatment which has been in place since that time. **See Structural Analysis section.**

*Fig.12: Serious vertical crack and displacement extending from lancet top*

4. As the prime reason for the bulges and cracks in the tower is the unconsolidated rubble in the core, then, if the cladding were to be removed, a grouting procedure is required to unify the inner and outer wythes with the core. The grout should be selected with care, as this intervention will for all intents and purposes be totally irreversible. With a consolidated core, the tower will be stable without the cladding, except in a severe seismic event.

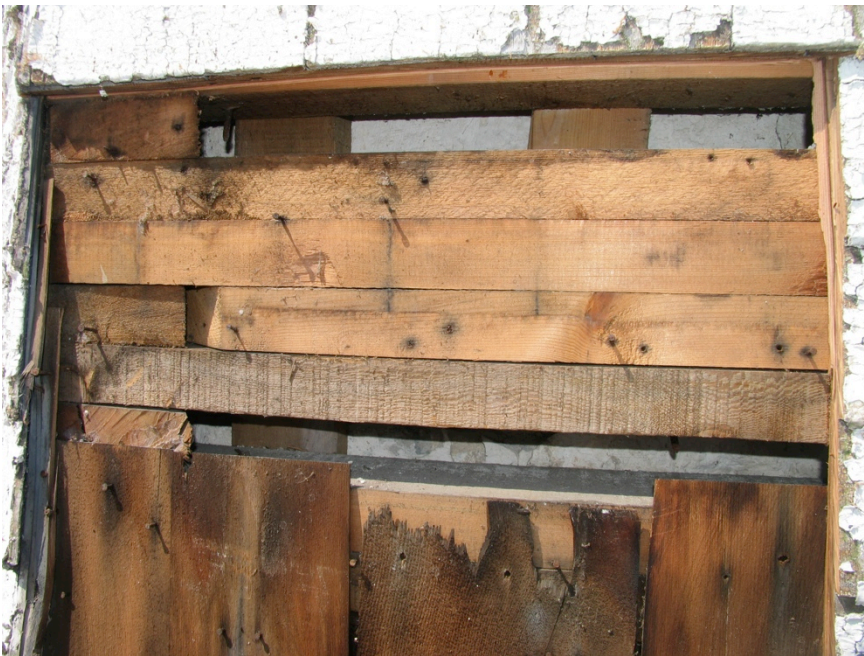
In the areas opened up for the recent investigation the timber was sound with no evidence of deterioration/decay. Horizontal boards were secured to 2" x 4" sawn wood furring. Surprisingly not all furring strips were continuous through the areas opened up for examination. Horizontal members were cross-lapped at the corners. The dimension and exact configuration of members varied depending on location. At the south/southwest corner and mid-height this consisted of full 2" x 4" sawn lumber ganged as four members with a 2" gap above and below". As part of this treatment a 4" section was carried across the corner as one laminated 4" x 4" (Fig.12). At the middle of the south elevation there was a combination of 2" x 4"s (3) and 2" x 2"s (1) with no discernible gap within the area opened up. Toward the top south to southeast corner "2 x 4's alternated with 2 x 2"s in a solid assembly. Above (5<sup>th</sup> storey) it appeared to be solid 2"x2" members. It is likely that considerations such as the irregularity of the stone surface in different areas, the level of stability required in specific areas and the need for ventilation between the stone, the timber and the shingles influenced the range of configurations witnessed. Surprisingly no fasteners from the furring into the stone were encountered and all the

*Fig.13: Various girt configurations are used with cross-lapped corbers*

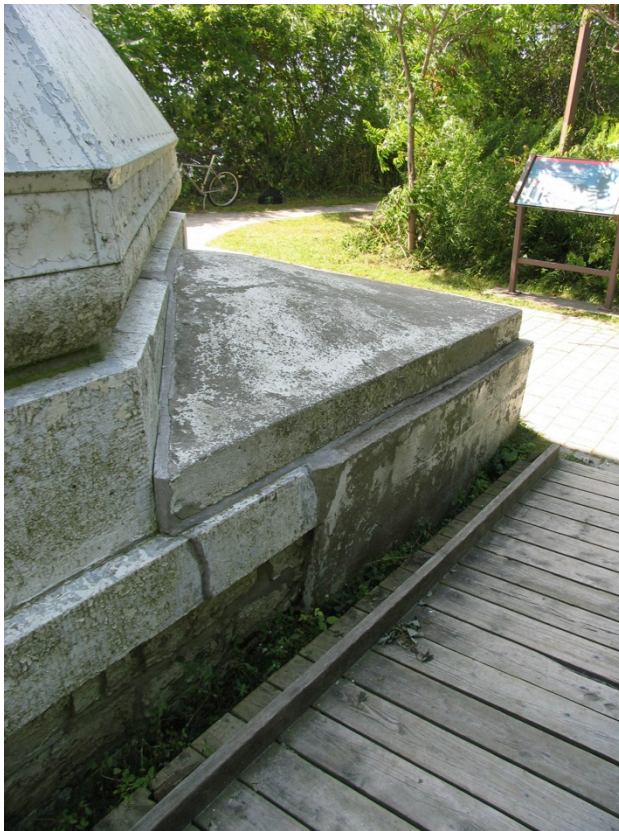
However, the problems are still substantial. The top of each corner has been built up in concrete intended to improve drainage. It is not clear whether they have been cast against an original shoulder detail or are concrete right through. This may vary from corner to corner. The northwest corner is actually completely covered in concrete and/or cementitious parging which itself is beginning to crack. All these corners are beginning to pull away from the lighthouse walls with the northwest and southeast the most pronounced – with cracks extending through the projecting foundation cap course as well as the gap widening at the joint between the built-up shoulder and the octagonal wall common to all the corners. There are many vertical cracks through the plinth block, particularly at the front. The rubble stone of the foundation walls is also unstable at the southeast corner. The cardinal foundation elevations that are in line with the walls above fare better though there is substantial cracking at the front step of the entrance and at the plinth along the front (west).

*Fig.14: North-west corner*

Restore exposed stonework at base: \$35000.00  
(includes: replace stone step; Jahn repair of cracks; break out concrete shoulders, investigate, conserve stone, possibly repour concrete,, repoint joints and clean vertical cracks; premachink corners; pinning at cracked quoins and minor dismantle and rebuild)

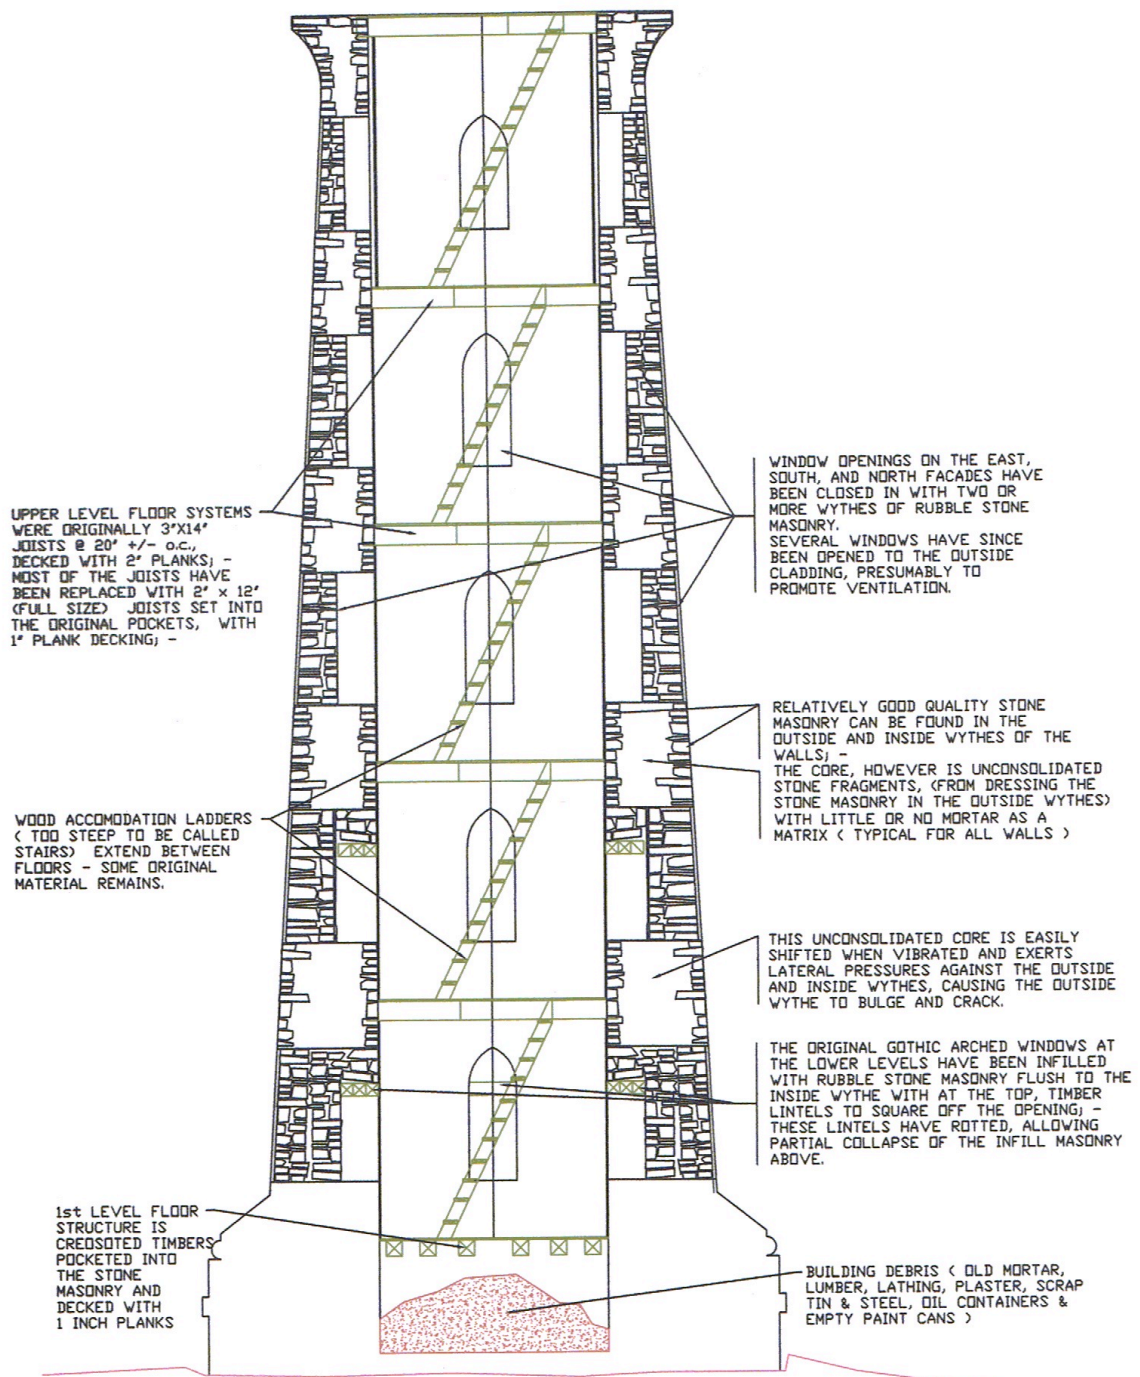
SKETCH # 3

VERTICAL SECTION THROUGH THE NORTH - SOUTH WALLS  
ILLUSTRATING THE CLOSED-IN WINDOWS AND THE  
AS-FOUND MASONRY CONDITIONS ( OUTSIDE CLADDING NOT SHOWN )

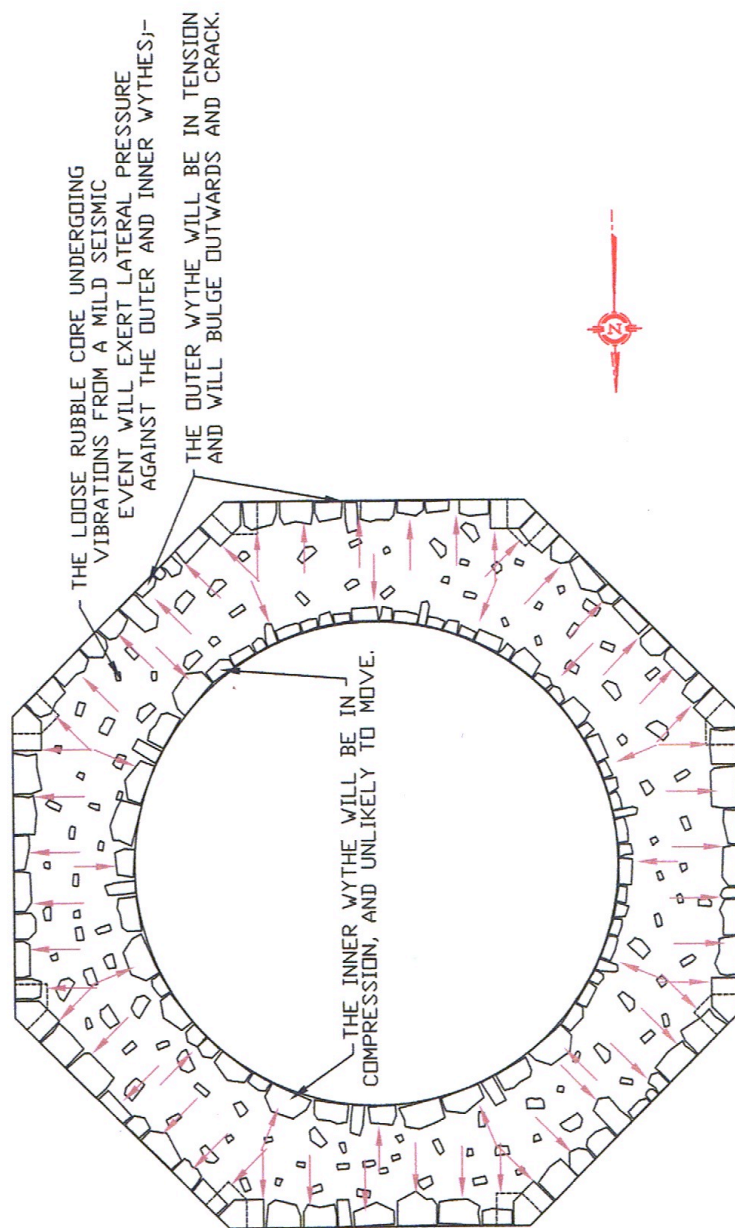
staining of what might have been mortar on a few stones in the other bore holes. The inner wythe or core is unconsolidated rubble and does not contribute to the strength of the tower in any way, so that the outer and inner wythes (cylinders) while supporting the vertical weight of the tower, also provide the confining strength keeping the loose core stones in place. ( See Sketches #4 & 5 for original specified construction techniques)

In a mild seismic event, vibrations (lateral and vertical movement ) would cause these loose stones to exert pressure against the outer and inner wythes . The outer wythe would thus be acting in tension, and the inner wythe in compression. Stone masonry acts very well in compression, but poorly in tension and it is likely that vertical cracks would open in the outer wythe in the weakest areas (probably between the vertically-in-line windows – (See Sketch # 6)). The existing timber cladding acts as a confining shell, and while cracks may occur in the outer wythe, there has been little or no displacement of the stone masonry. It is unclear whether the addition of timber cladding had this intention in the 1894 rehabilitation of the lighthouse, but it certainly has performed well as a structural system, keeping the tower intact.

SECTION THROUGH STRUCTURE SHOWING LATERAL  
LOADS FROM THE UNCONSOLIDATED CORE  
SKETCH # 6

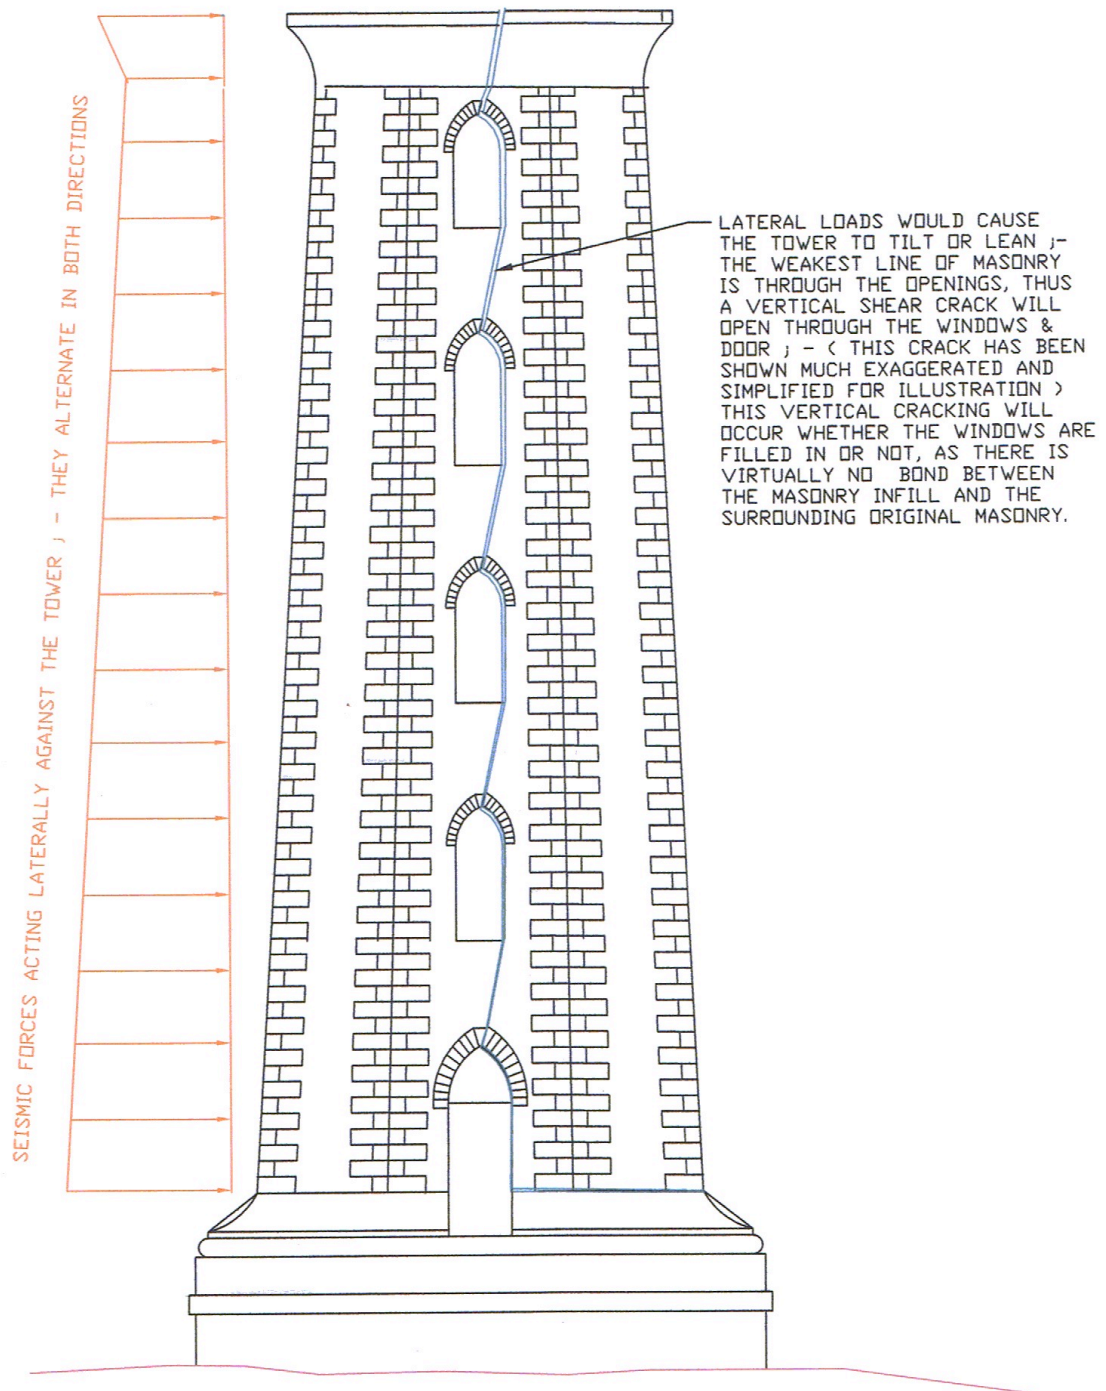
SKETCH # 7

In a strong seismic event, the tower would experience lateral swaying, which would set up vertical shear stresses. These shear stresses would concentrate at the tops of the gothic arches of the windows and door, and a crack would probably develop and move vertically through the windows. (See Sketch # 7) These cracks would show up on both the exterior and interior wythes. The infill of these windows on the north, east, and south walls would probably not alleviate these stress induced cracks as the infill masonry is not structurally keyed into the original masonry. Similarly, the timber cladding on the exterior, while providing a confining shell for the tower, is flexible enough so that it would not prevent side sway, and cracks in the masonry would still be expected in the event of a major shake. Cracks through the tower as a whole, induced by high seismic forces are a major weakening of the structural system, and there could be partial collapse. Extensive repairs would probably be required to stabilize the structure. It would appear that there have been no major seismic events in the last 176 years as there are no visible seismic type cracks on the interior of this building.

WEST ELEVATION SHOWING DOOR & WINDOWS  
ILLUSTRATING THE EFFECTS OF A SEVERE  
SEISMIC LOAD ON THE TOWER.

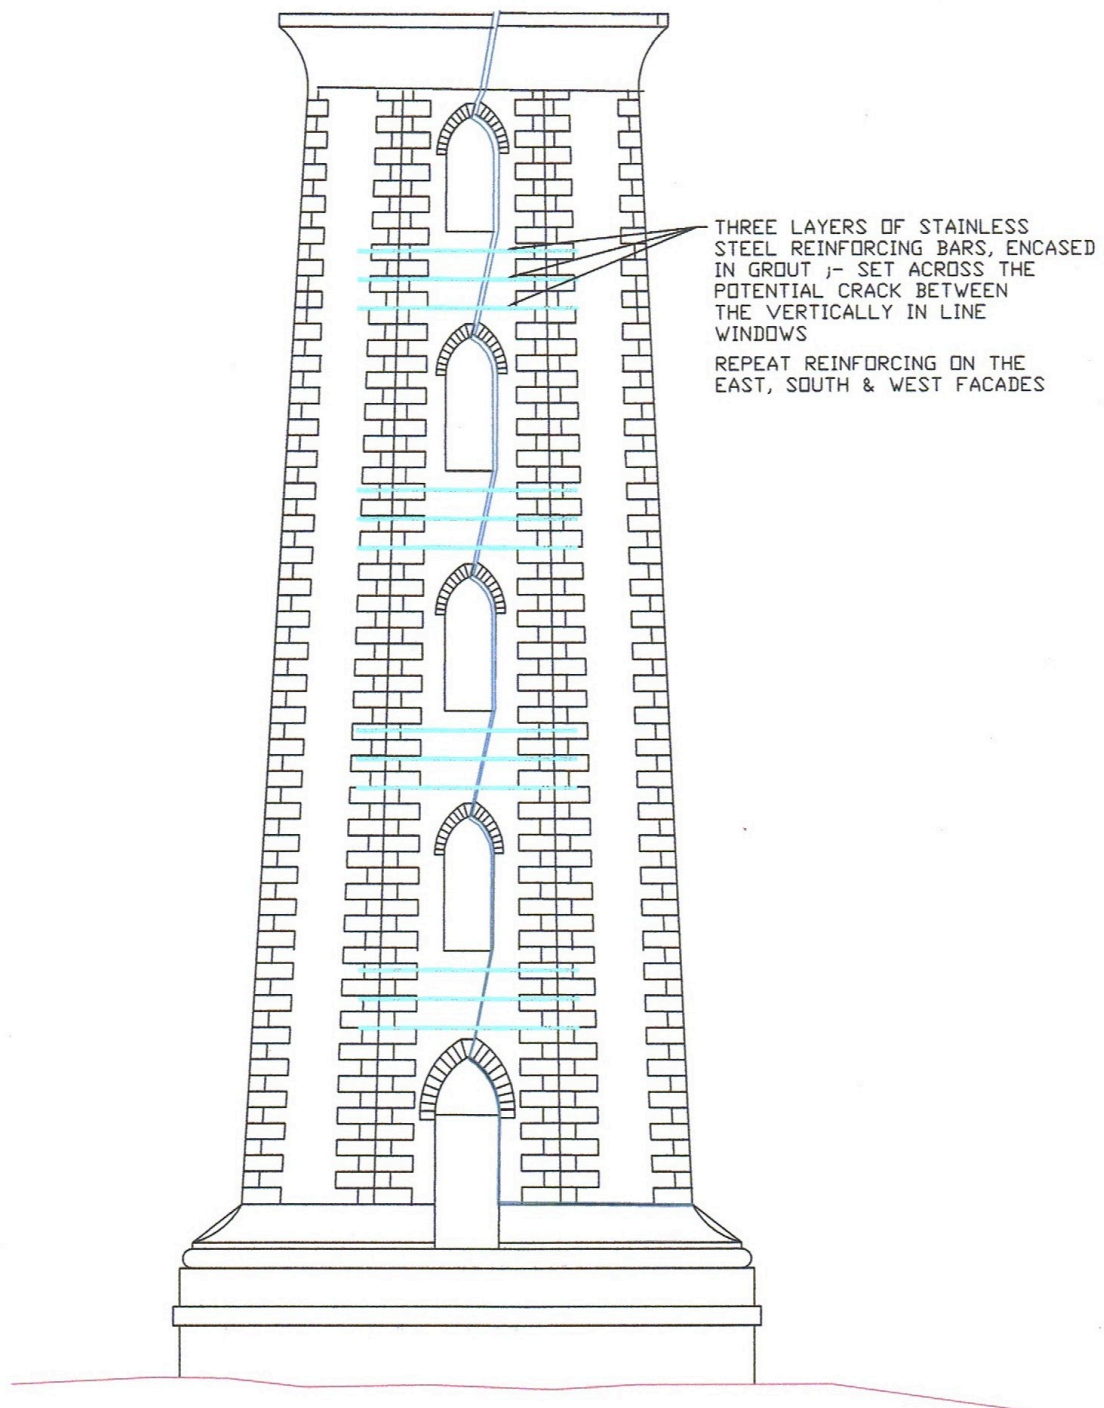
RELATIVELY GOOD QUALITY STONE  
QUOINS CAN BE FOUND AROUND  
OUTSIDE OF THE OPENING;

Alternatively, without closing in the openings, a ridged, rust resistant steel frame could be inserted into the window or door opening, and then deeply ( 150 – 200mm) fastened into the surrounding masonry . (See Sketch # 10)

WEST ELEVATION SHOWING PROPOSED HORIZONTAL  
CINTEC TYPE REINFORCEMENT ; -  
SKETCH # 9 NOT FOR DESIGN

FABRICATE A STEEL FRAME IN GALV.  
50mm X 6mm Sq. Hollow Steel STOCK  
DRILL AND GROUT IN 5/8"Ø X 8"  
STAINLESS STEEL THREADED ROD  
INTO THE MASONRY ADJACENT TO THE  
FRAME AND ATTACH TO THE FRAME  
WITH S.S. BRACKETS;-
