PILOT CONSERVATION PROJECT STRATEGY DEVELOPMENT REPORT

**Presqu'ile Point Lighthouse
Brighton, Ontario**

**Prepared for: Presqu'ile Point Lighthouse Preservation Society
June 2016**

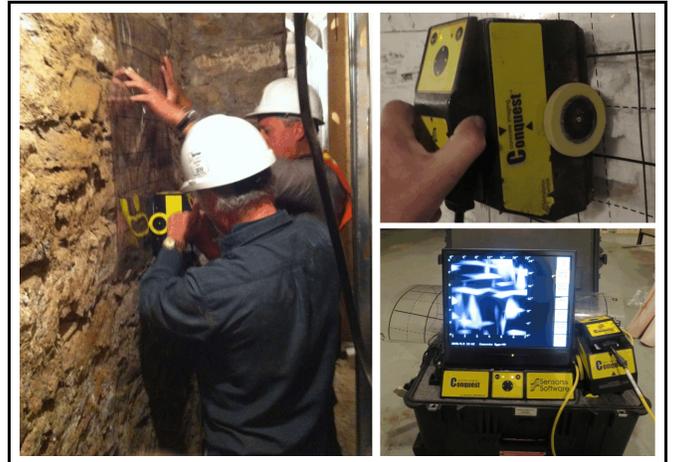
Photo. 4 (left): Scanning a location using Ground Penetrating Radar. Photo. 5 (upper right) The scanning head moved over a temporary grid. Photo 6. (Lower right): A typical scan of a grid slice visually interpreted by the computer.

.1 GPR is a non-destructive test method which incorporates radar antennas that emit very short, precisely timed pulses of radio frequency energy into the structure under test. The pulses are emitted from a scanning head when connected odometer wheels are moved over a temporary 24-in x 24-in (600-mm x 600-mm) test grid at 4-in (100-mm) spacings on an 'X' & 'Y' axis (See Photographs 4 & 5 from a previous project). Part of the energy subsequently echoes back to the surface to be analysed by a computer, which records how "loud" the signal is and how long it takes to return to the antenna. A computer software program is then used to analyse the raw data and generate the results and images. (See Photograph 6.)

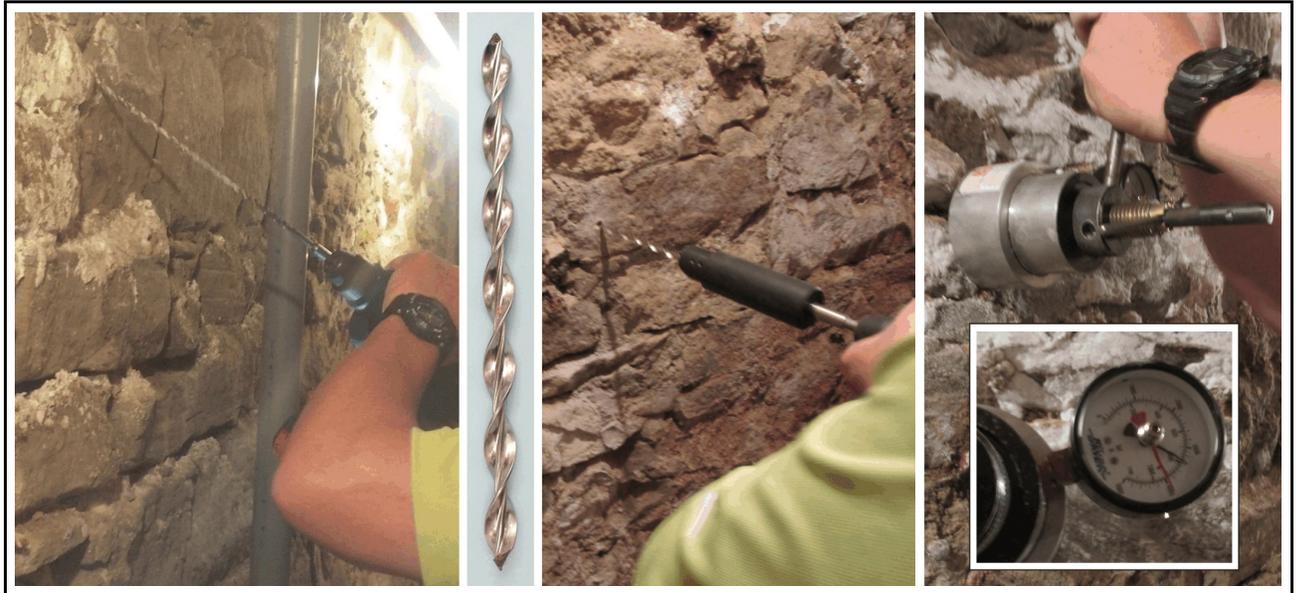
Photo.7 : (Left) Installing a stainless steel helical masonry tie. Photo. 8: (Second from left) An illustration of a stainless steel helical masonry tie. Photo. 9 : (Centre) Installation of a tie within a pilot hole. Photo. 10: (Right with inset image.) Testing an installed tie using a pull-off testing device to apply an axial load.

.1 A series of pilot holes should first be drilled through mortar joints (See Photo 7). The masonry ties illustrated by Photograph 8 should then be installed into the pilot holes using a purpose designed "dry-set" installation tool (See Photo 9). Testing of ties can then be achieved by securing a direct tensile pull-off testing device over the protruding ends and applying axial loads (See Photo 10 with inset image). The information from the tests will facilitate the establishment of more reliable cost estimates for the subsequent primary work. Locations for tie installations can also be selected so that information provided by the GPR tests can be verified.

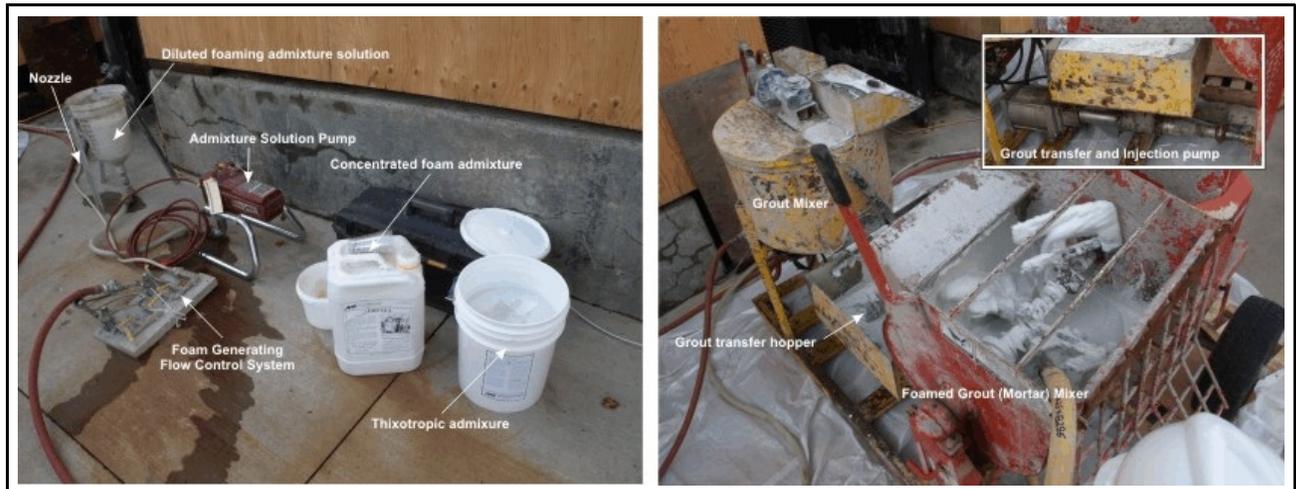
Photo 11: (Left) Equipment and materials for generating foam. Photo 12: (Right) Equipment set up for producing foamed grout.

- .4 The mixture should then be transferred to a conventional horizontal spiral blade mortar mixer. Foaming equipment should then be utilized for the development of a cellular foam which should then be blended (folded) into the mixed cement grout. (See Photographs 11 & 12 for illustrations of the type of recommended equipment and materials.)

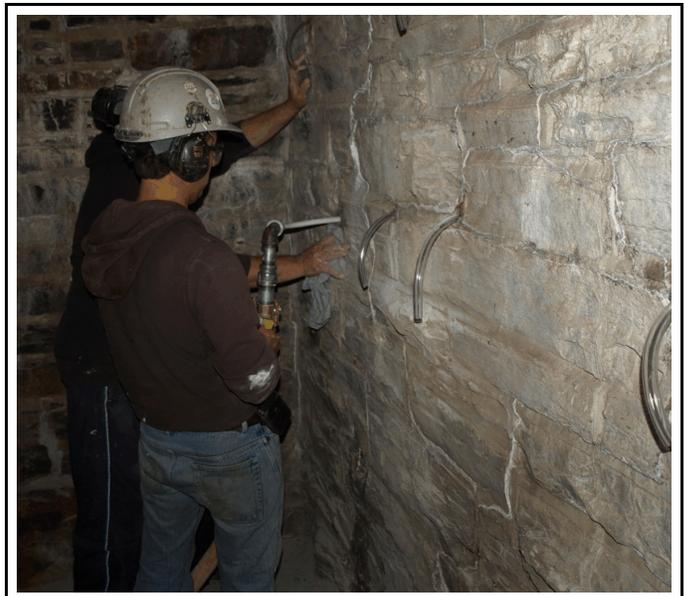
Photo. 13: Using low pressure to inject the cellular foamed cement grout into a traditional mass masonry wall. (Dingle Tower, Halifax)

- .5 After adjustments of the volume of foam required for the desired density range, the blended cellular foam grout should then be transferred into a pump and injected into the masonry through tubes inserted into pre-drilled 12-inch (300-mm) minimum deep holes installed at 24-in (600-mm) centres through mortar joints. (See Photograph 13 for an example installation.) Open joints which could facilitate grout leakage should be temporarily plugged as work proceeds using a hydraulic cement mortar. Return valves should be fitted at the end of nozzles and the pump pressure controlled to be approximately 5-psi (345-mbar) above the observed pump pressure when flow is unrestricted.

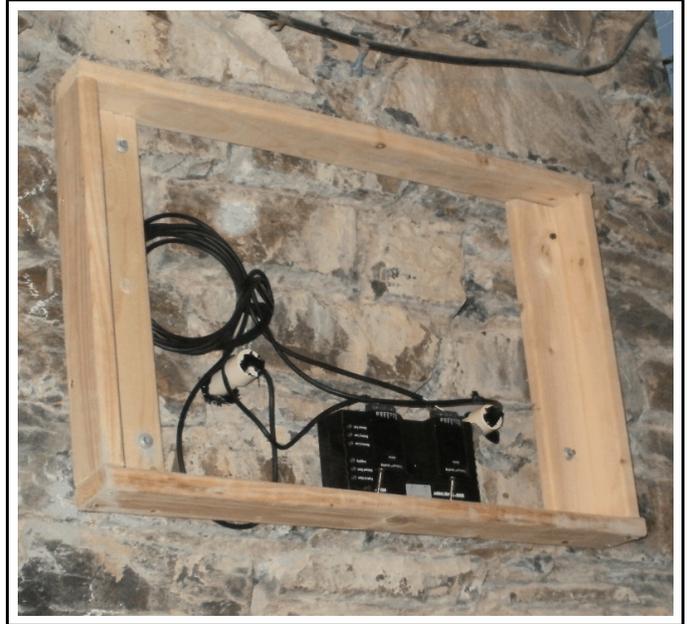
Photo. 14: Example of installed sensors set to monitor moisture conditions within a tower's masonry assembly.

- 4.12 Under the supervision of PJMC, the condition of the walls should be evaluated for moisture levels. A series of sensors that measure both relative humidity and moisture should be installed into the walls at various locations, connected to data loggers and set to record measurements every four hours. (See Photograph 14) Data from the sensors should then be evaluated over time to assess the levels of moisture at various locations and determine whether the masonry has the ability to naturally dry to a reasonable level, or whether the Primary Conservation Strategy will require a conditioning component.
